11 July 2005
Issue Number 0505

Paper Machine Breast Roll Fatality

25 May, 2005

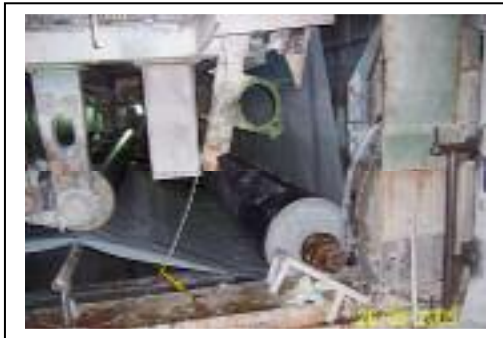
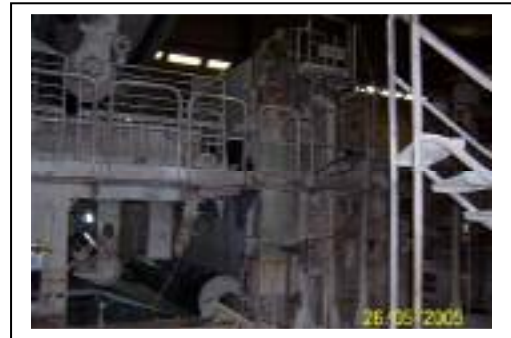
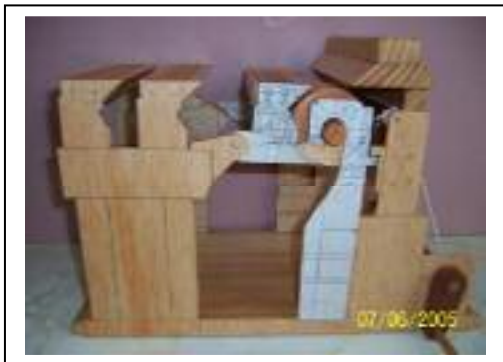
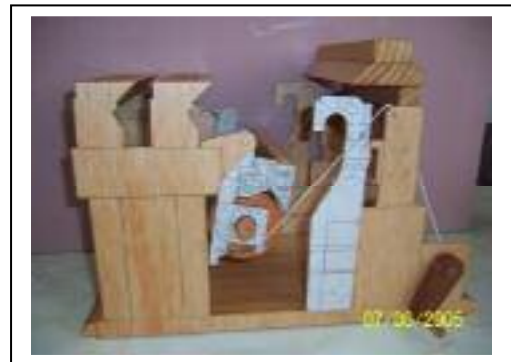
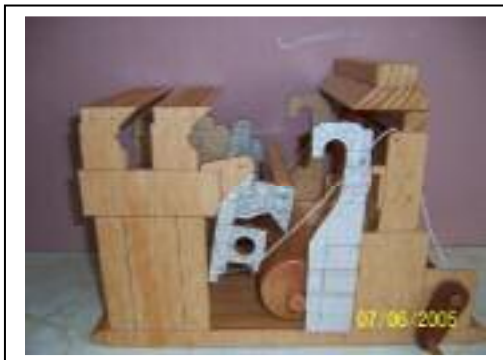
As the breast roll was being raised into position at approximately 7.30PM, there was a loud crash and the breast roll swung back and fell to the machine sole plates adjacent to the wire pit.

The investigation team determined there were two root causes of this incident. They were:

- 1. "As per accepted practice, the employee was under or adjacent to the suspended load around the machine sole plate and was struck when the front breast roll lowering frame fell back causing injuries which proved fatal.*
- 2. When lifting the breast roll into position, the front side winch cable was not connected. When the breast roll was lifted to contact with the roll lock bracket and with the air motor driven to stall, the load exerted on the back side cable caused it to fail catastrophically. As the front cable was not connected, the roll and front breast lowering frame fell back. The subsequent breakage of the rear breast roll lowering frame was caused by the immediate stop as it hit the machine frame."*

1. *That engineering and procedural changes must be made to the breast roll raising / lowering mechanism to reduce the risk of a similar occurrence.*

- a) Investigate the feasibility of eliminating the wire changing mechanism and replacing it with a pneumatic lift mechanism.
- b) An additional operating lever to be installed at the back of the machine to operate in series with the front lever

- c) The bearing holding clamp to be fitted with a pneumatic arm so operators no longer have to manually lift the arm from below
- d) A guard to be installed to prevent access to the area below the suspended load.

- e) A guard to be installed on the cables and air motor high speed drive coupling to prevent entanglement.
- f) The front operating lever to be relocated above the elevated walkway so that the operator can see the position of the roll when being raised.

- g) Work procedures should include a requirement to re-attach the cable and pin
- h) An air-operated limit switch and striker plate to be installed to prevent the swing arm contacting the roll lock bracket.

- i) Air pressure available to the gearbox be maintained at 415kpa (60 psi) to ensure the unit cannot exceed its Factor of Safety.
- j) Appropriate warning notice to be located adjacent to the air switch – “Do not allow the arm to come in contact with the stop while the motor is engaged”.

- k) The work procedure must be modified following engineering changes to the mechanism
